SANDPOINT RAILROAD DEPOT

SANDPOINT, IDAHO

HISTORIC STRUCTURES REPORT AND MONITORING PLAN

Final
June 21, 2006

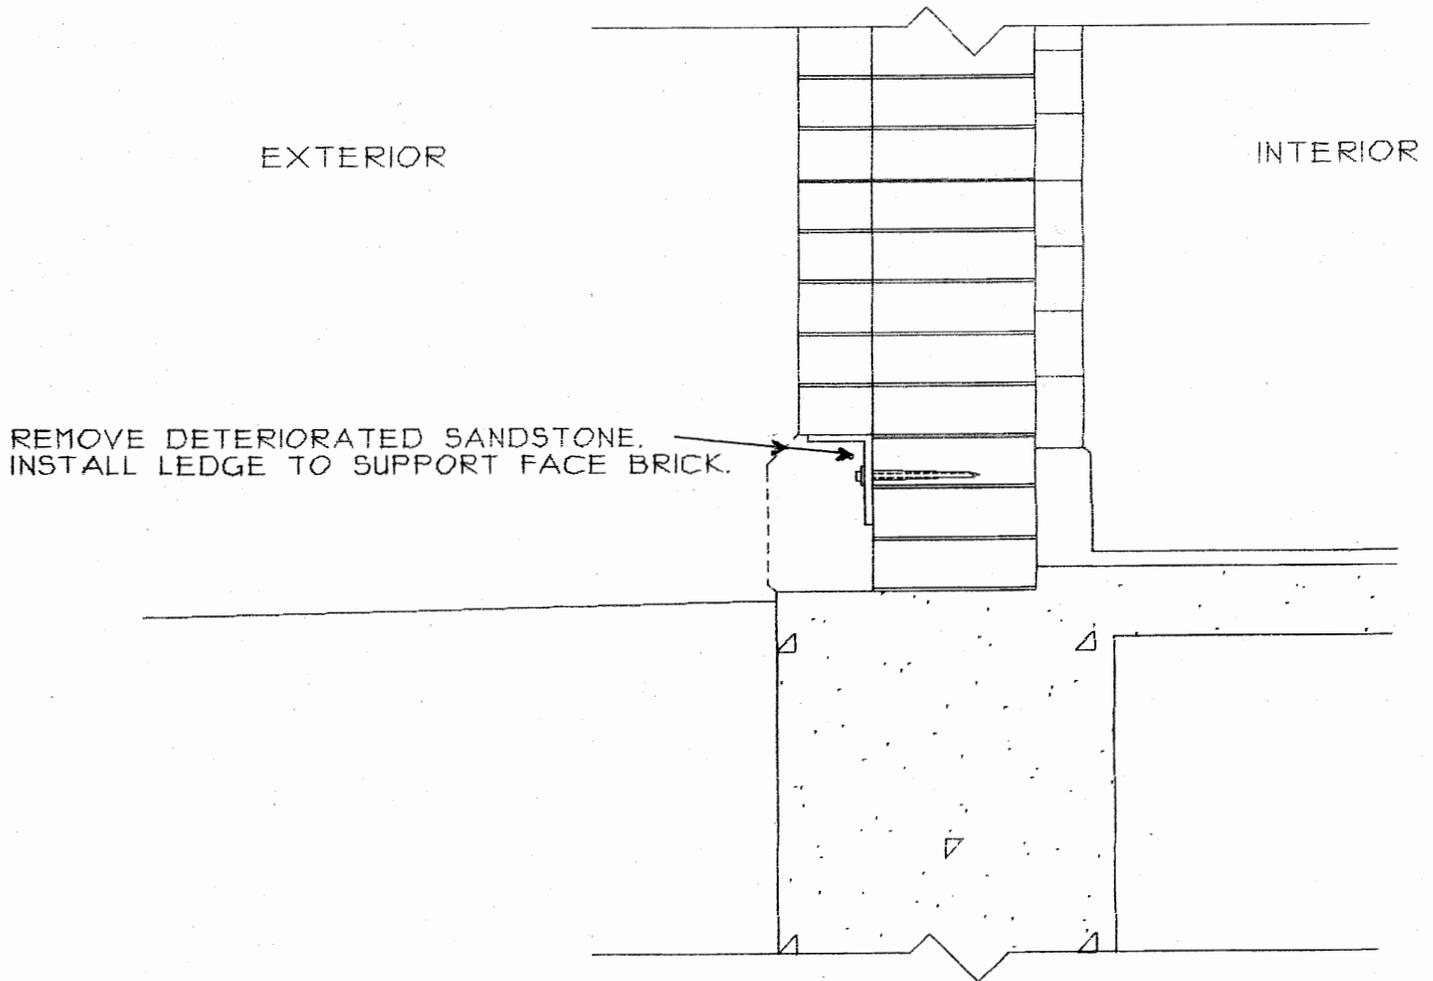
Exterior Wall Section at Sandstone Water Table

On the exterior, the sandstone base course has suffered from weathering, possibly de-icing of the adjacent pavement during winter, and abrasion of the surface from equipment and or vehicles over the past ninety years. The sill course also has similar problems, though of a lesser degree, as it's height served to prevent its deterioration (the height of the window sills). At the roof, the sandstone coping at the parapets has also suffered from weathering, plus mechanical attachment problems. It is assumed that dowels attach the sandstone pieces to the brick wall, but mortar joints have deteriorated or are completely missing.

NOTE: After sandstone replacement, discontinue the use of the de-icing agent adjacent to the sandstone water table.

2. Repoint all masonry joints at all faces of the four parapets to ensure solid connections between masonry units, including brick and sandstone coping.

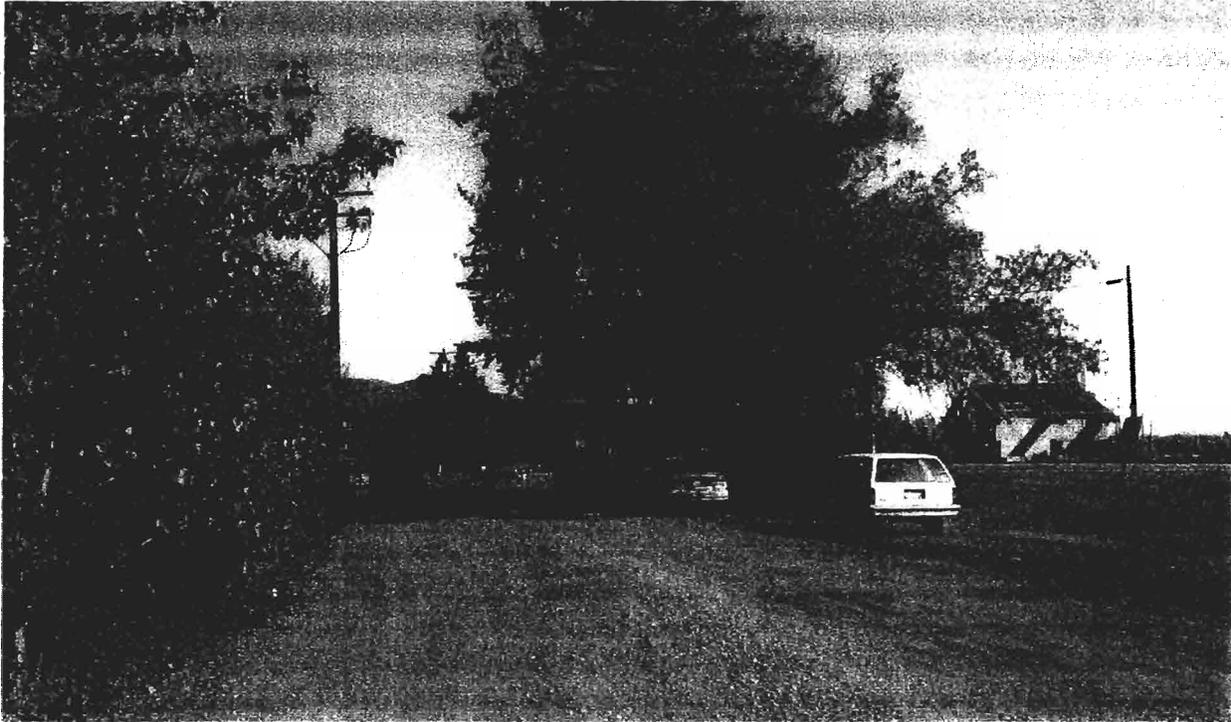
Trees at center to be protected and preserved.

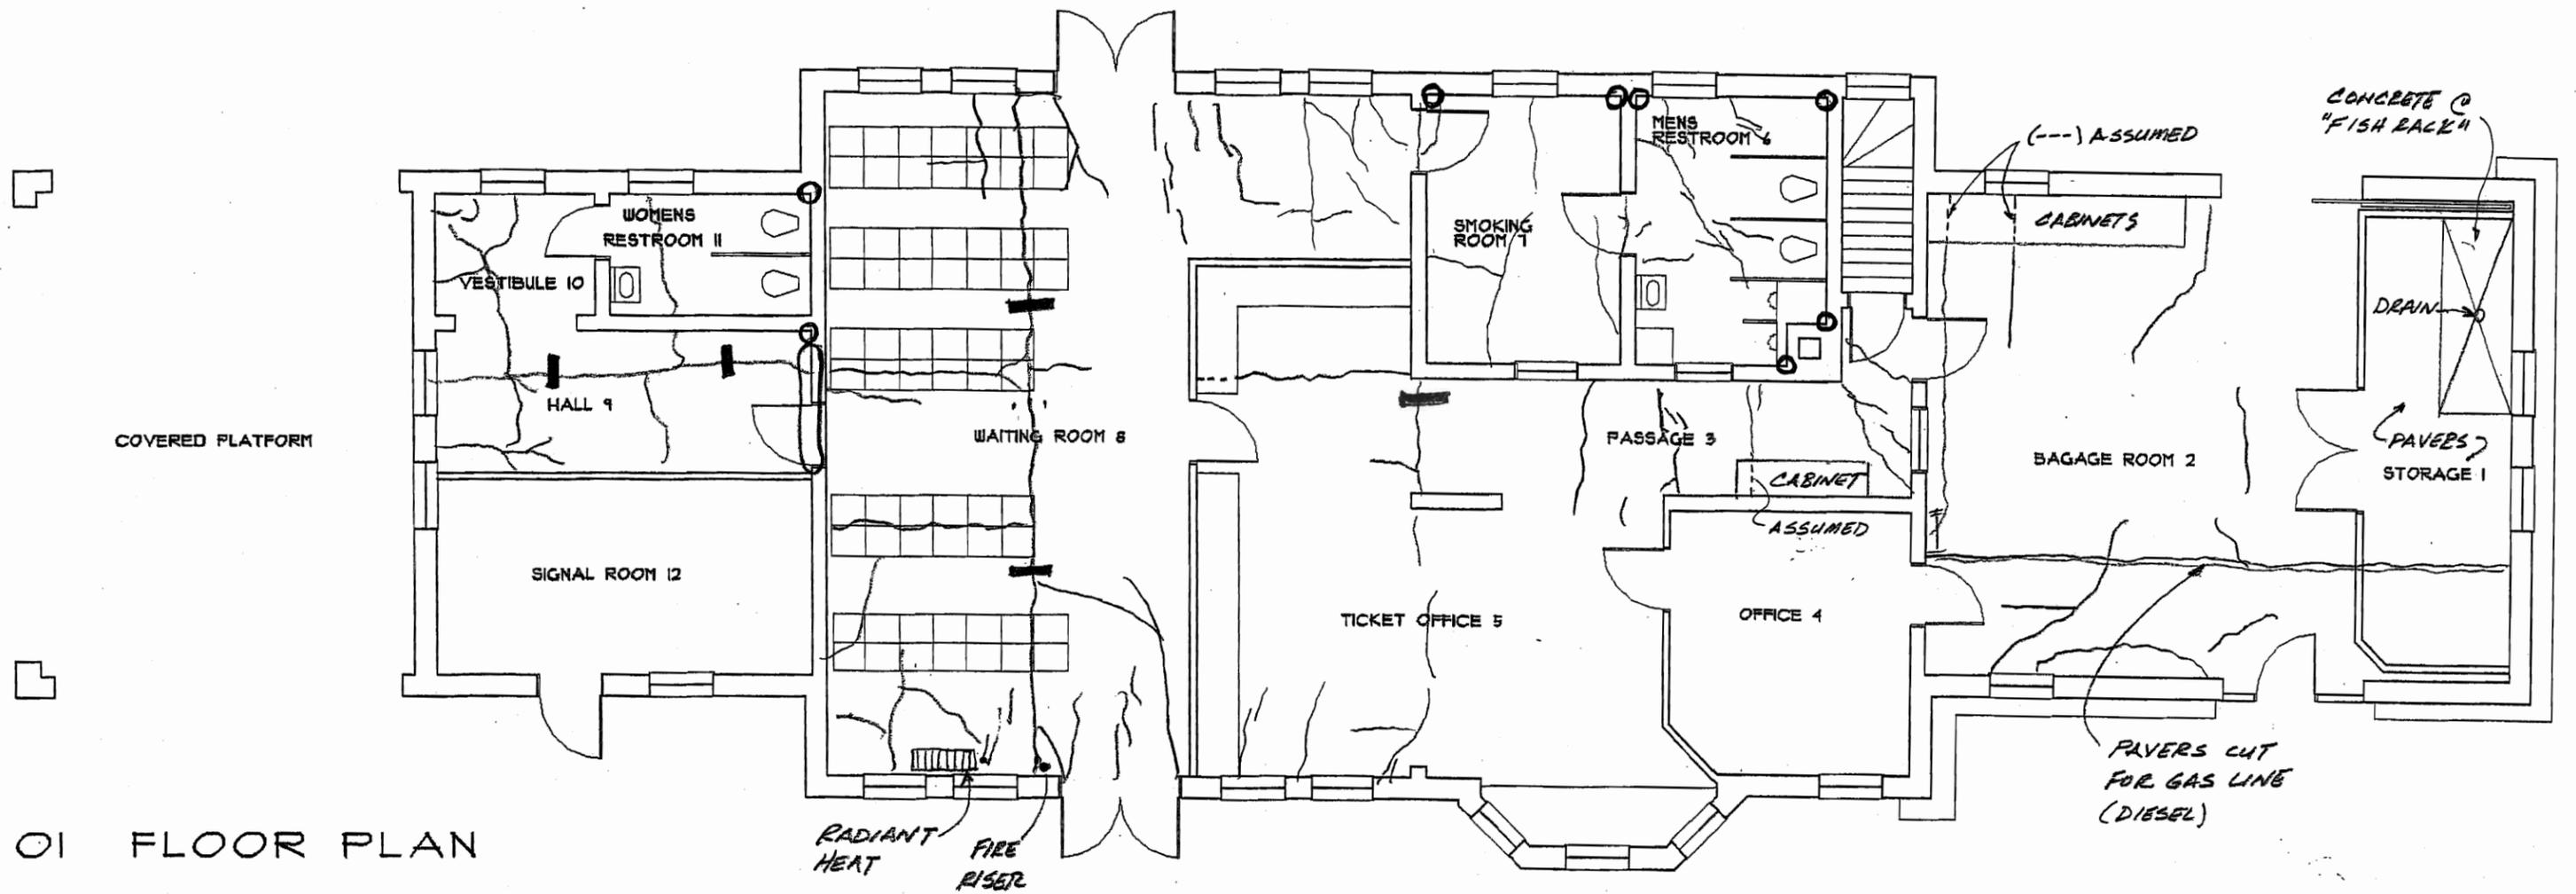
01 FLOOR PLAN

At the interior, the concrete slabs have cracked and caused the terrazzo floor finish to crack also. Some of these cracks have been repaired, but continuous movement has caused re-cracking. The enameled brick wainscot is in decent shape throughout, needing minimal joint repairs. The plaster walls have suffered serious cracking, as have the remaining original plaster ceilings.

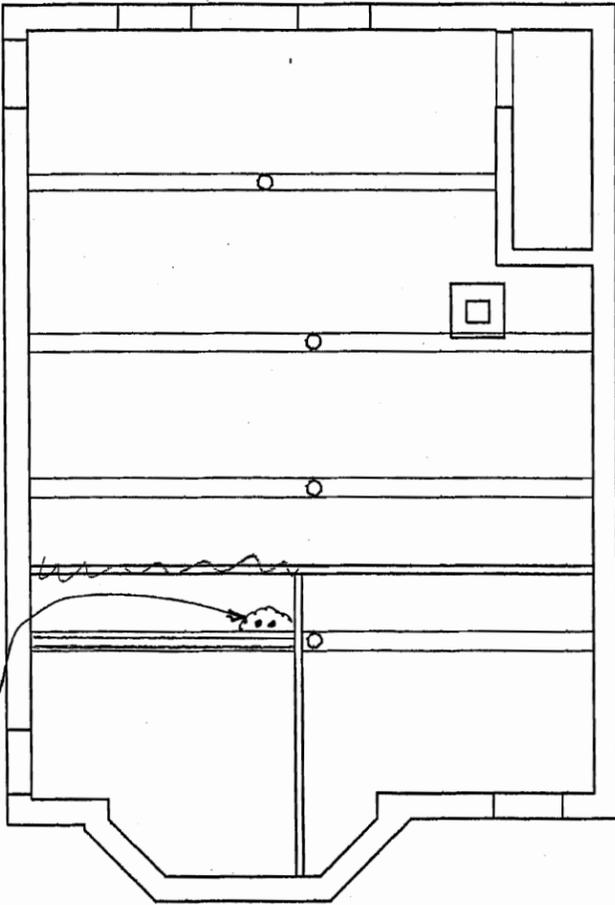
O2 BASEMENT REFLECTED CEILING PLAN

CONCRETE SPAWLED
WHERE TWO HOLES
WERE DRILLED
THRU FLOOR

MONITOR CRACKS AT HIGH & LOW POINTS, TYP.

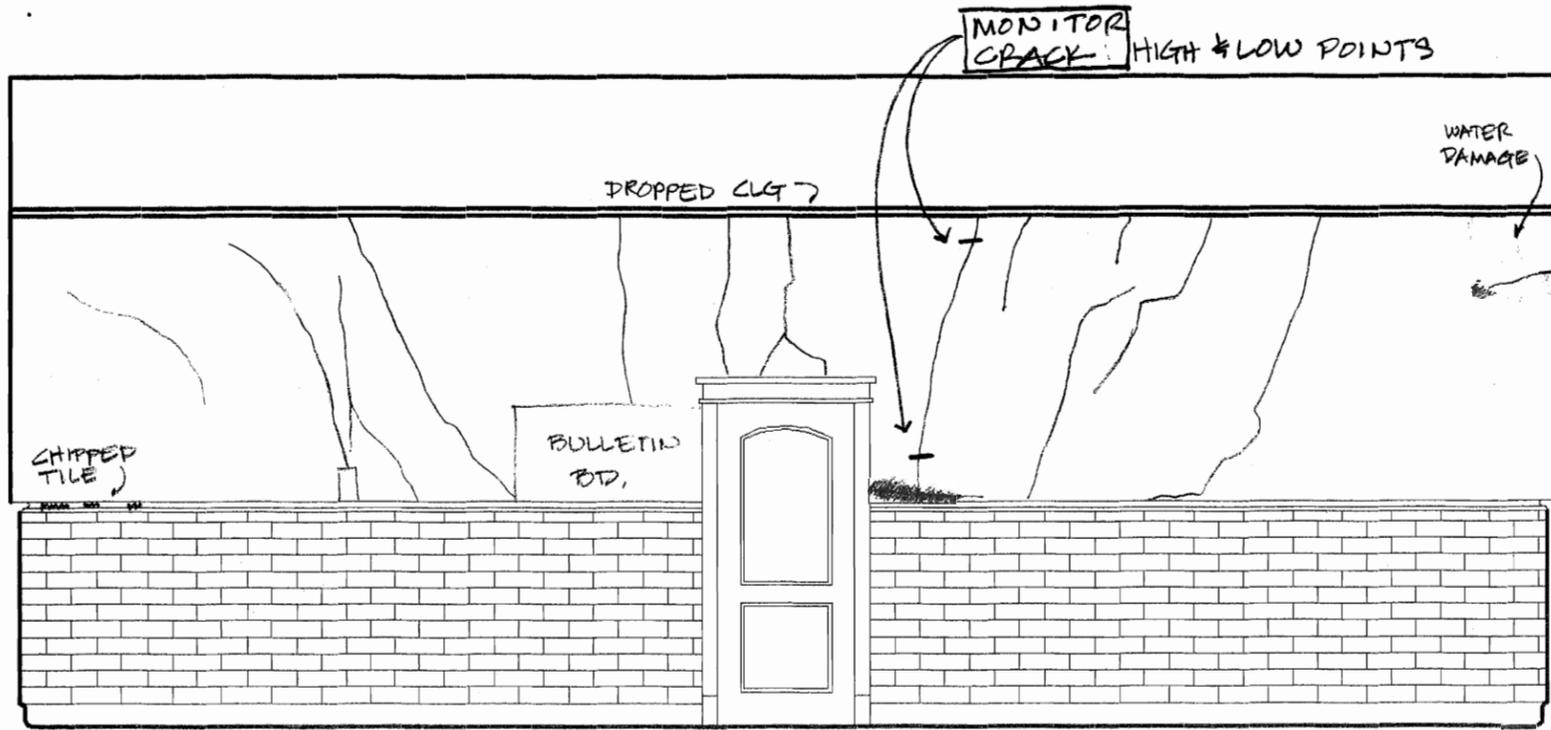
MULTIPLE CRACK @ PLASTER PLUS CHIPPING - TOP COAT

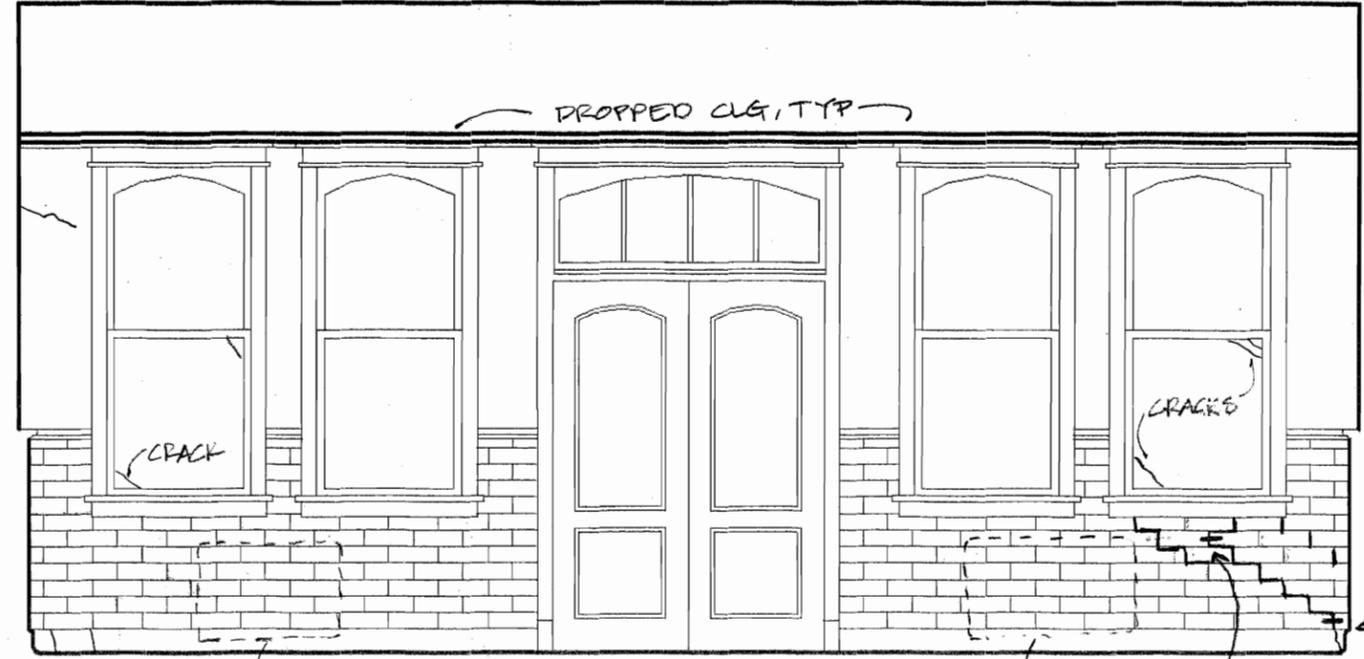
CRACKS @ TILE WAINSCOT & COVERED BASE

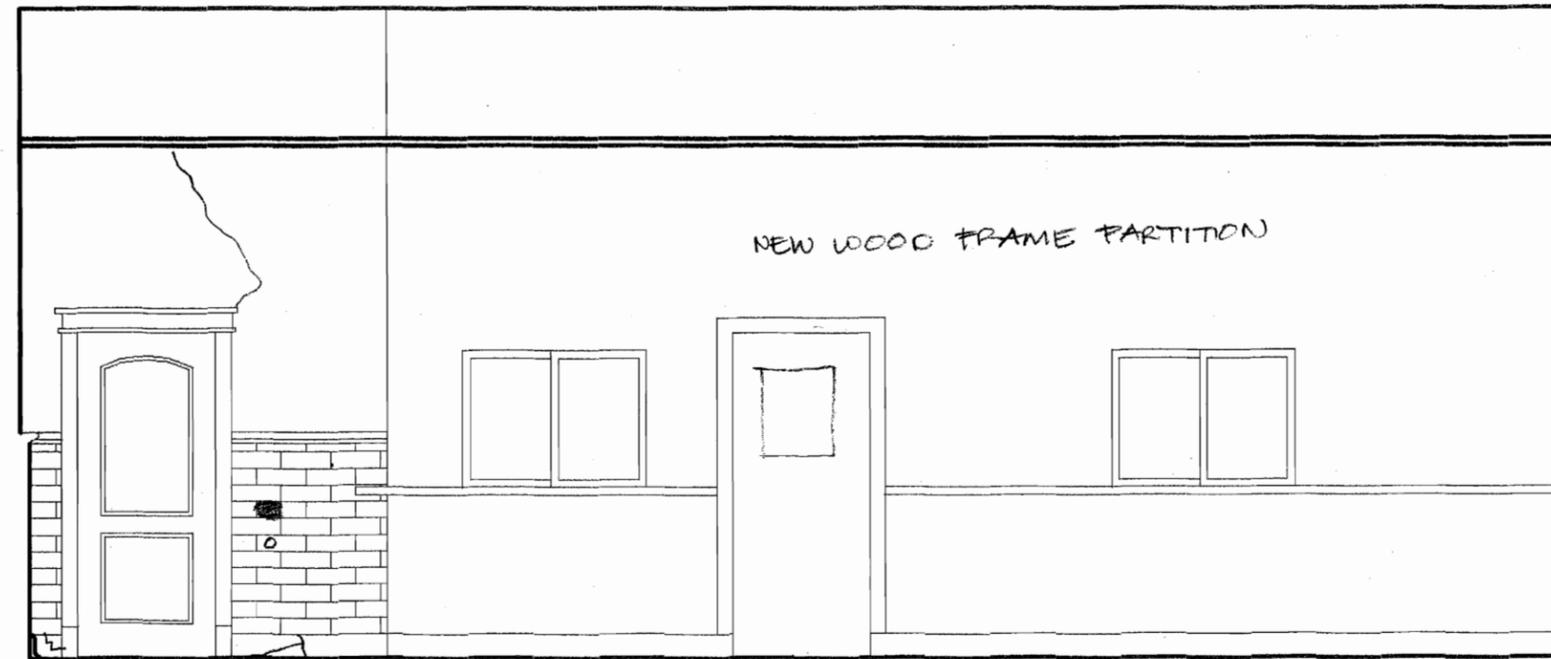
HOLE @ WALL - OLD D.F. PIPE

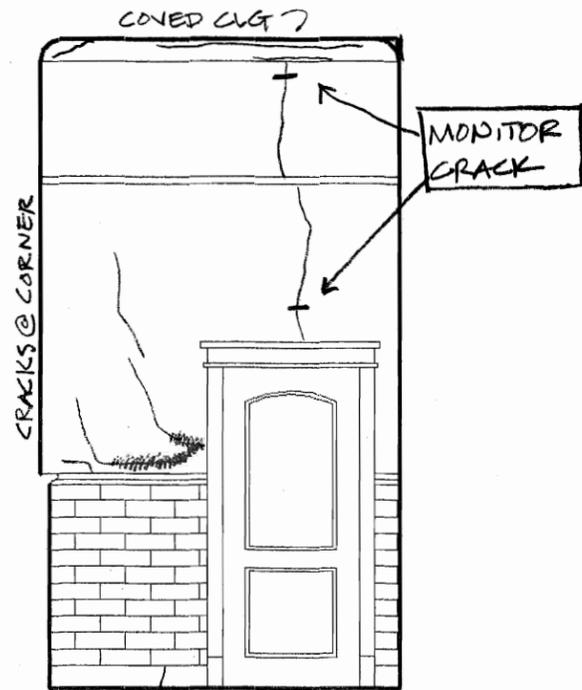
CRACK PLASTER
W/ CHIPPED TOP COAT

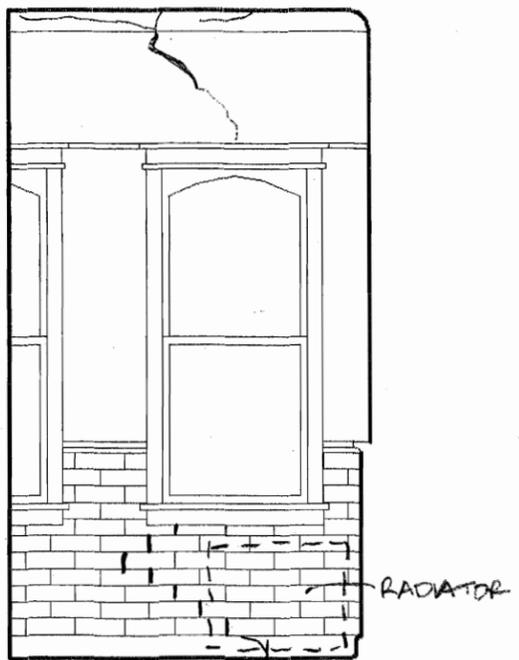
INDIVIDUAL
CRACKS @
VERTICAL JOINTS

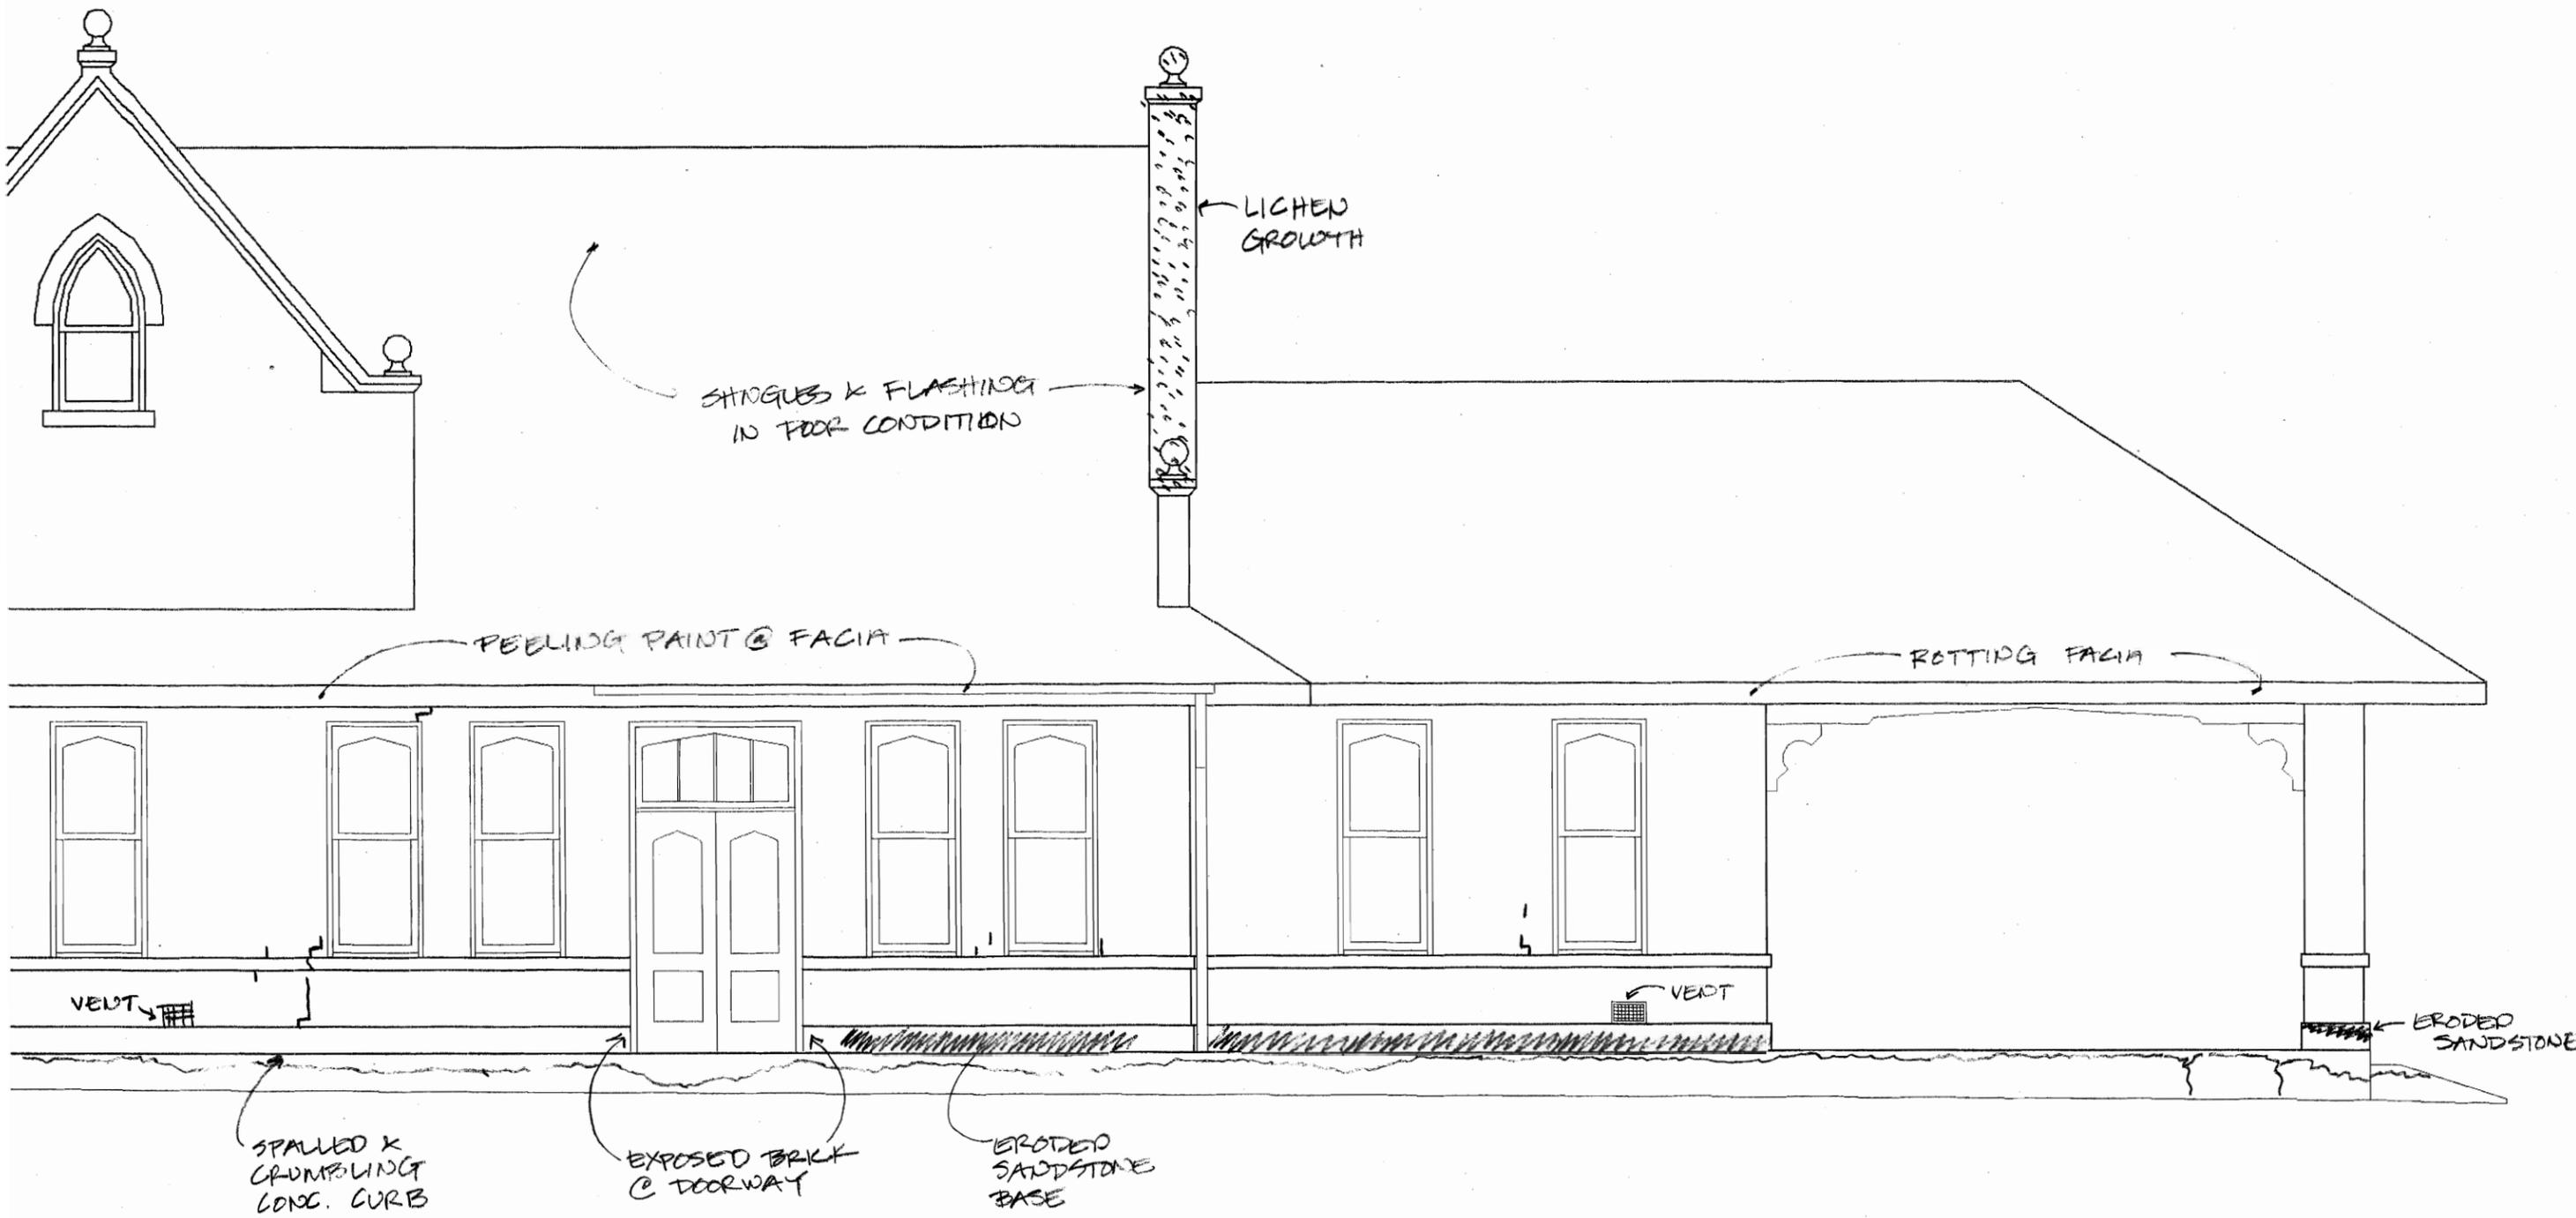
SHOQUES & FLASHINGS
IN POOR CONDITION

LICHEN
GROWTH

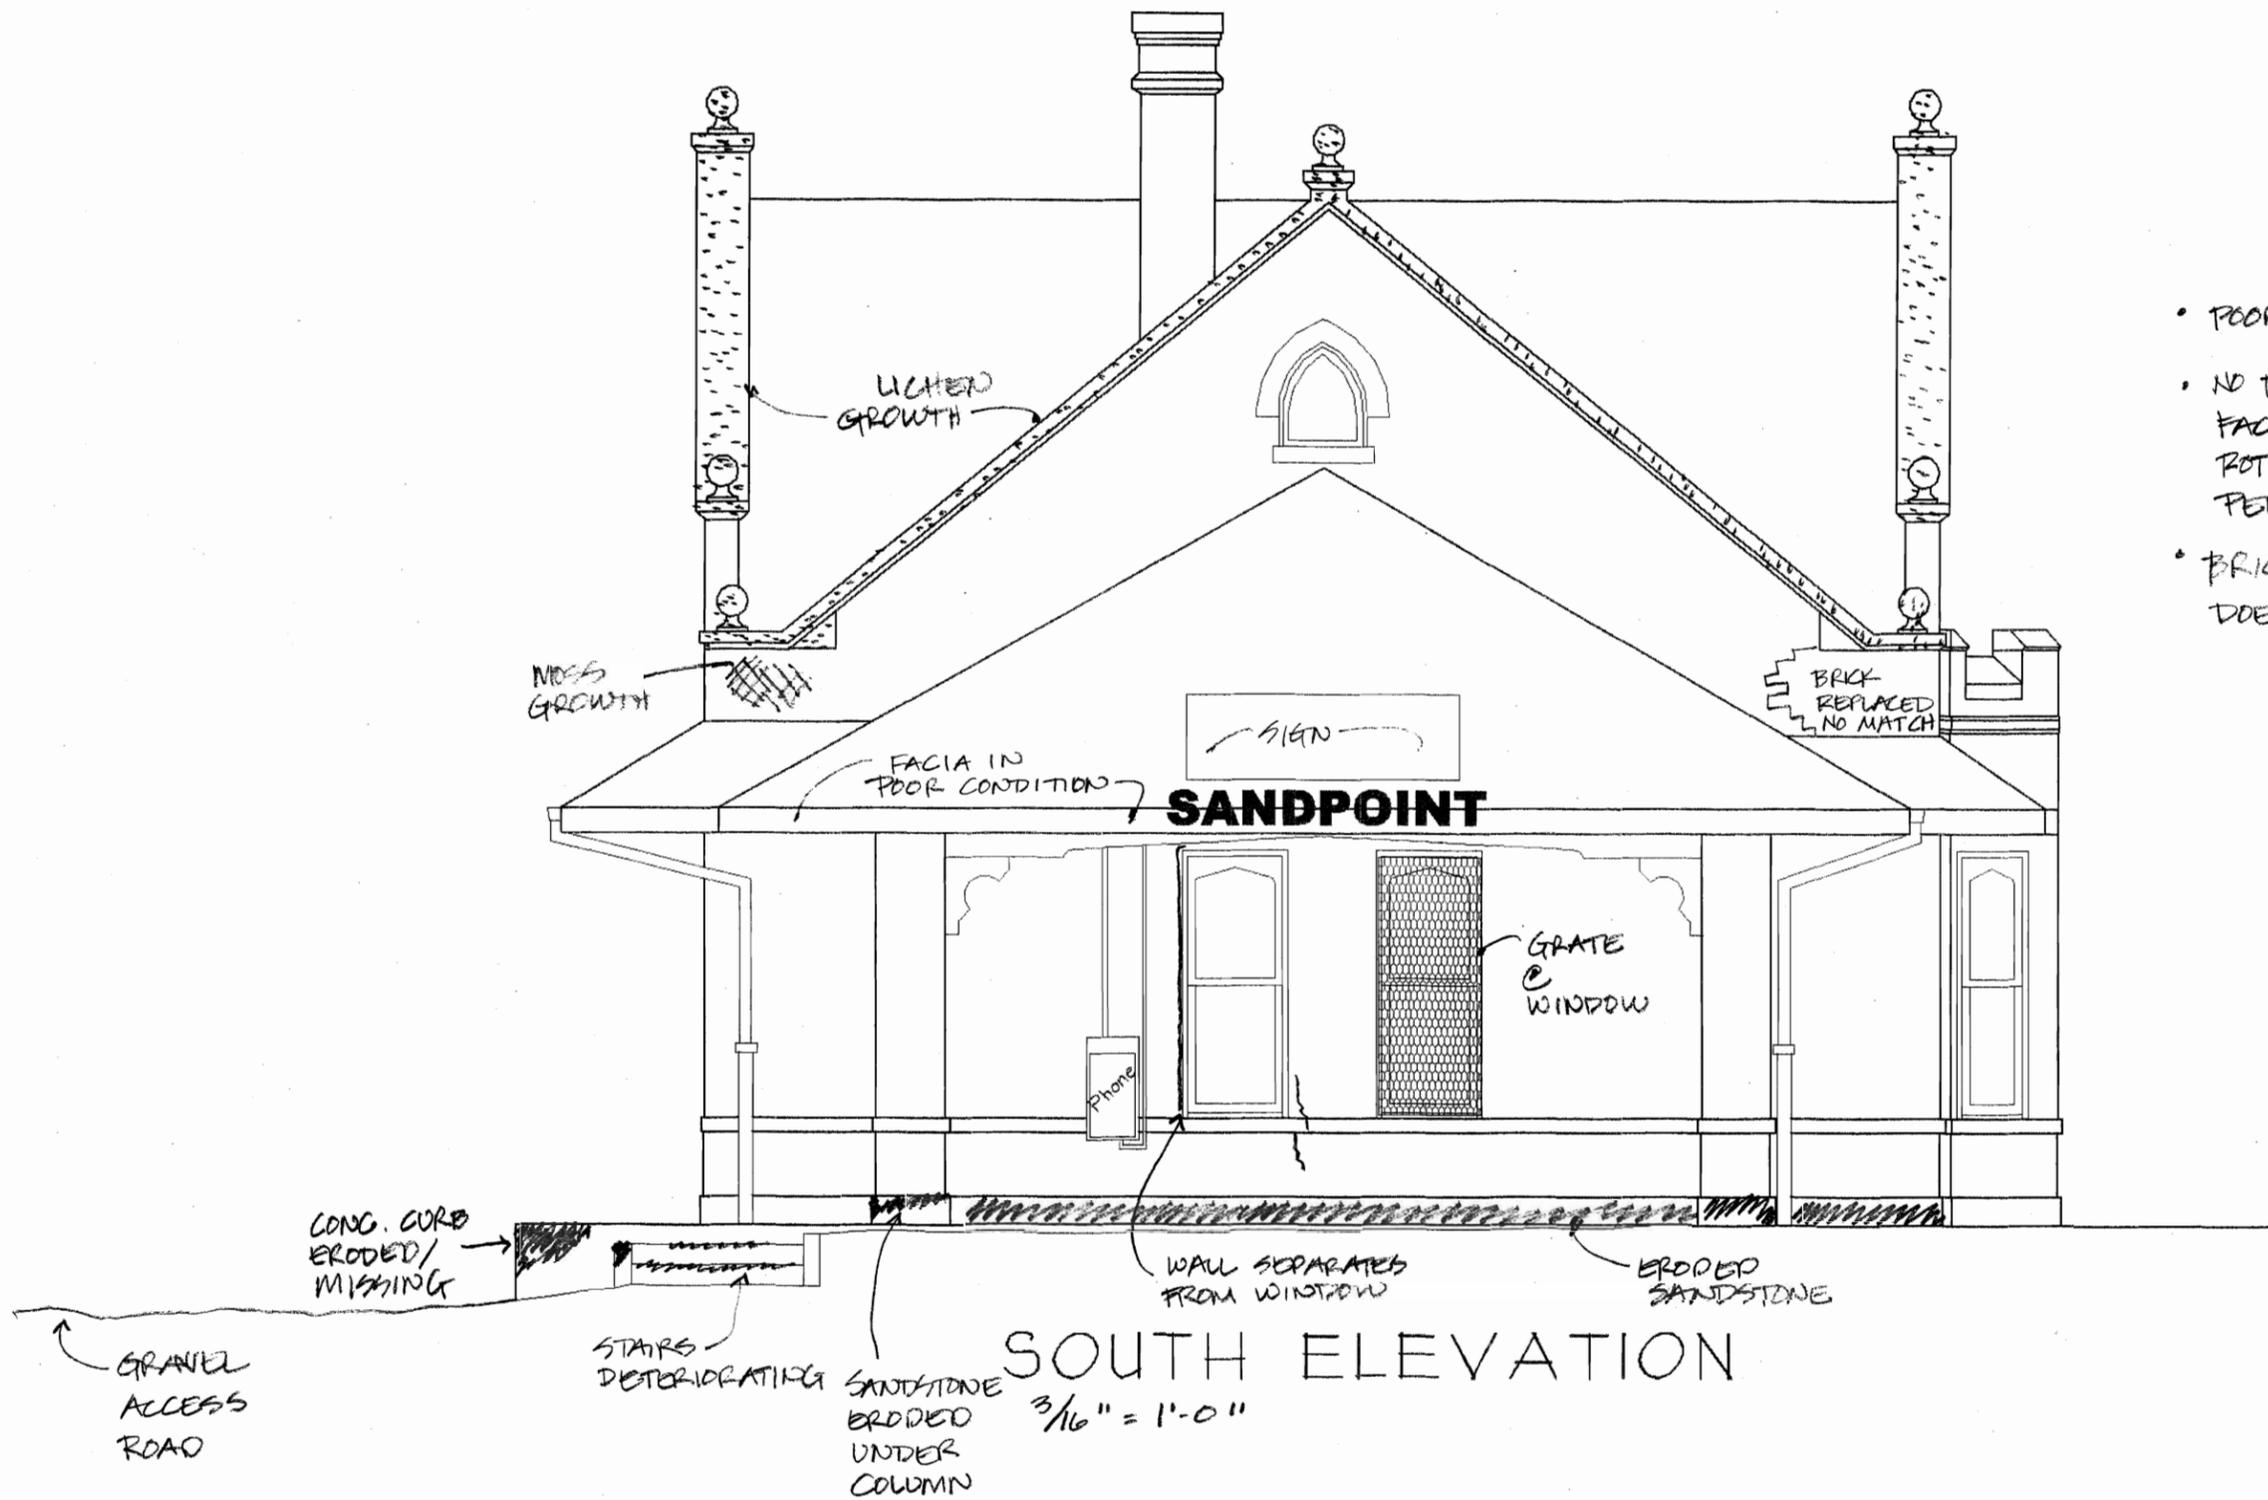
SOUTH ELEVATION

- POOR CONDITION OF SINGLES
- NO TRIP EDGE @ ROOF FACIA IN POOR CONDITION ROTTING & PAINT PEELING
- BRICK REPLACEMENT DOES NOT MATCH
