SANDPOINT RAILROAD DEPOT

SANDPOINT, IDAHO

HISTORIC STRUCTURES REPORT AND MONITORING PLAN

Final
June 21, 2006

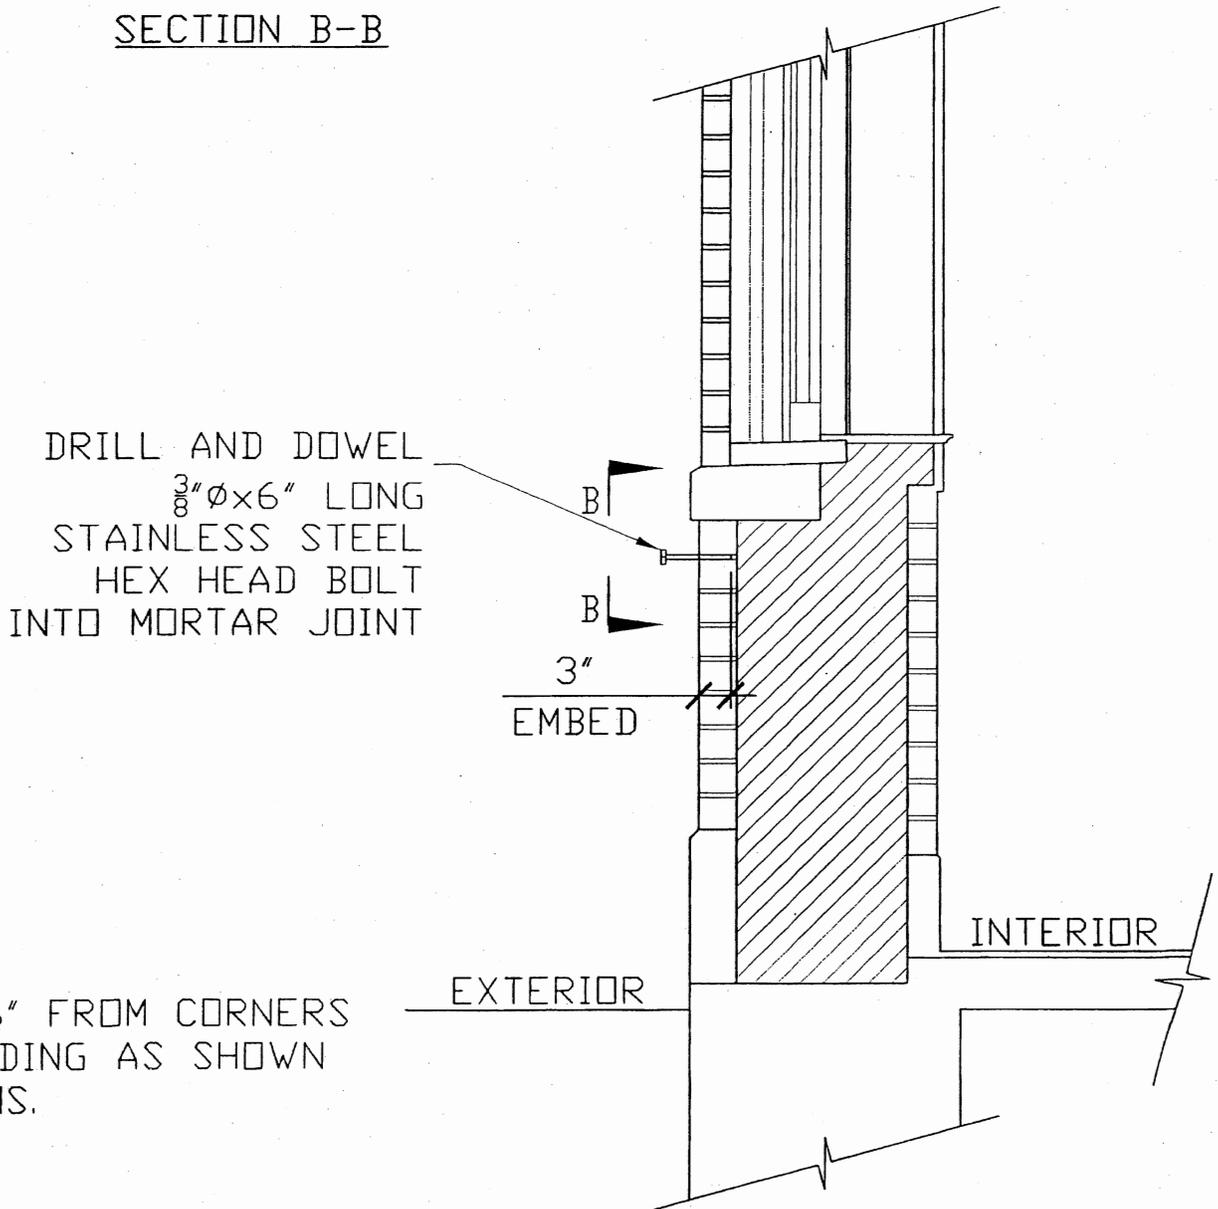
Bolt placement Detail

NOTE:
PLACE 6" FROM CORNERS
OF BUILDING AS SHOWN
ON PLANS.

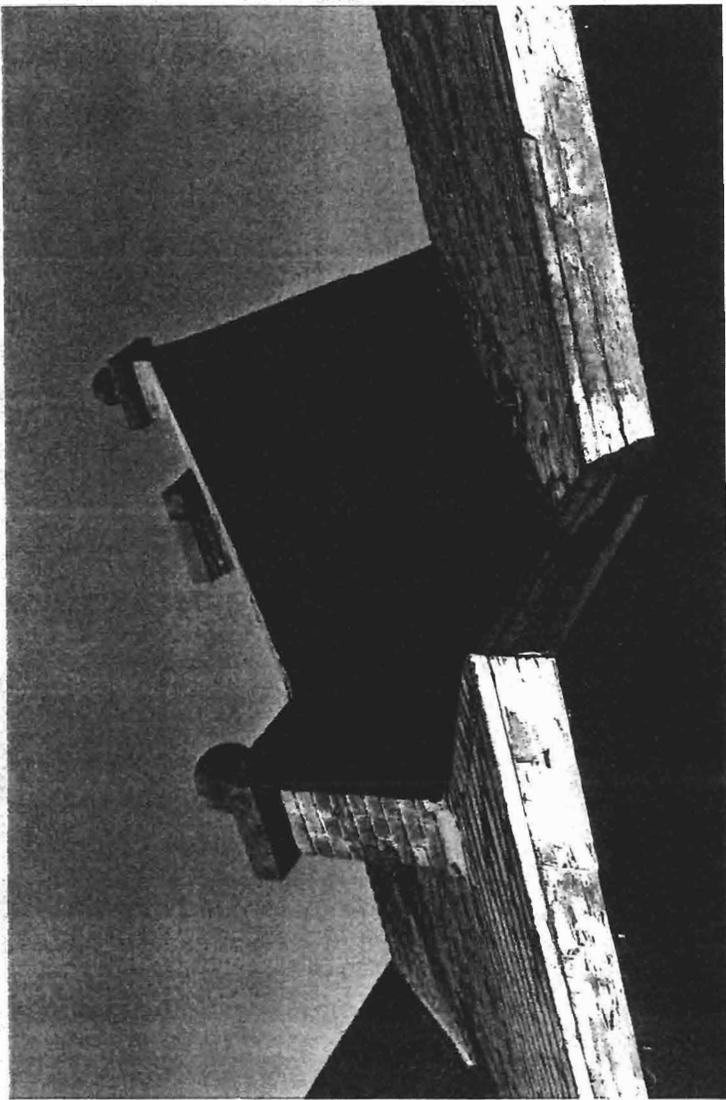
R1/F16
Sandpoint Depot
Roof & North
parapet

The parapets have suffered from the failure of the flashing and deterioration or loss of mortar. Excessive moisture has produced a build-up of lichen on all of the sandstone surfaces. Efflorescence is evident at the brick. A heavy build-up of moss has occurred on the roof at the north side of the south parapet. Moss is evident at the north side of the bay window. A sandstone orb at the north parapet is missing.

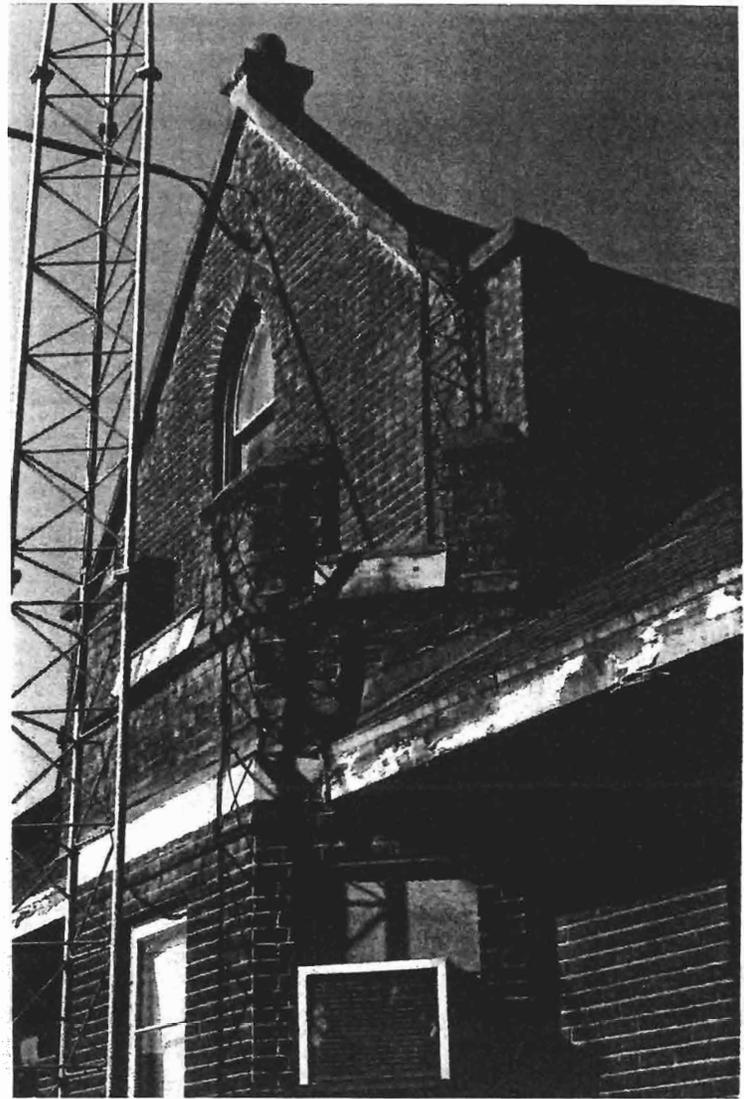
R1/F17
Sandpoint Depot
East parapet

Stepped flashing at the parapet walls is evident in some areas, where this flashing detail has failed, a long strip of sheet flashing was installed, not always adequately. Snow build-up on the north sides of the parapets has produced excessive moisture damage.

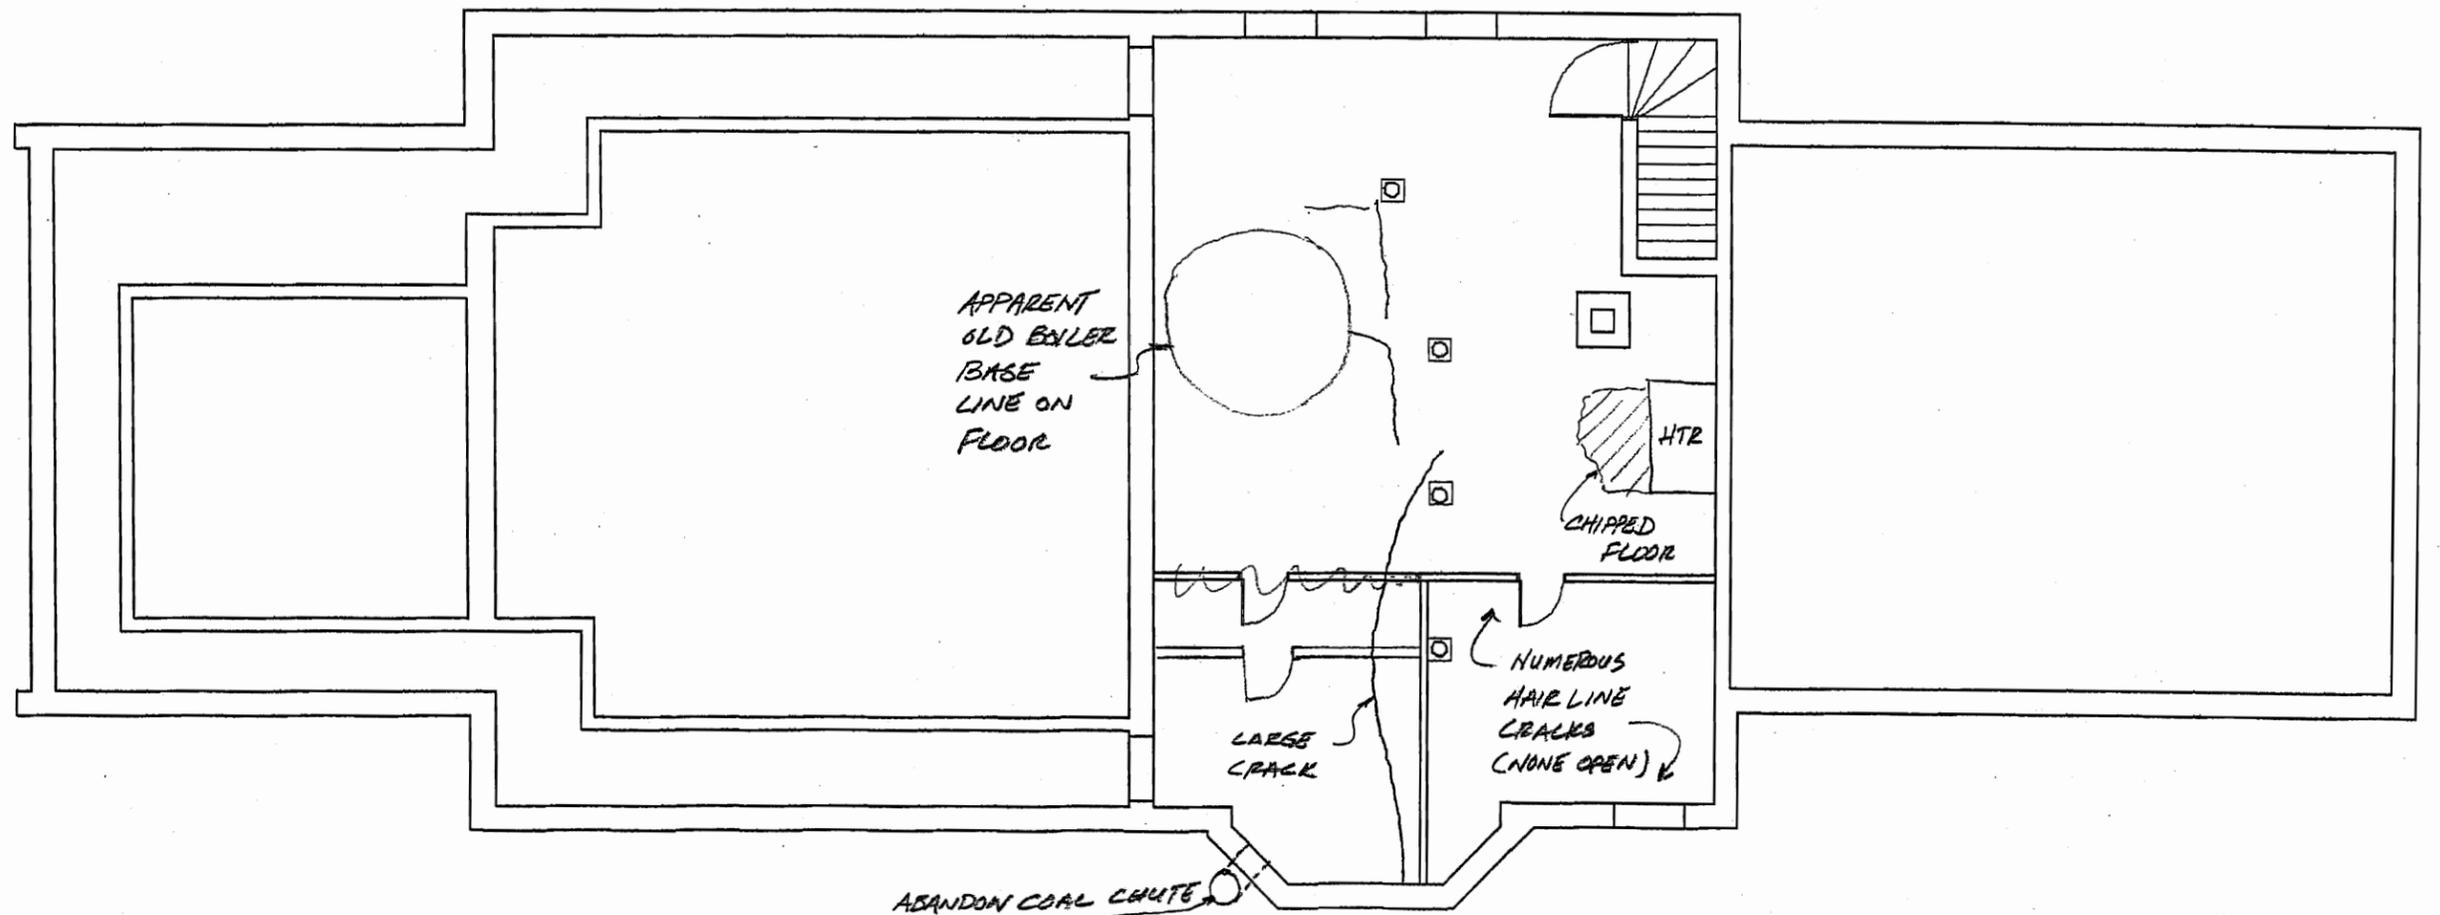
FLOOR CRACK PLAN

APPARENT
OLD BOILER
BASE
LINE ON
FLOOR

NUMEROUS
HAIR LINE
CRACKS
(NONE OPEN)

LARGE
CRACK

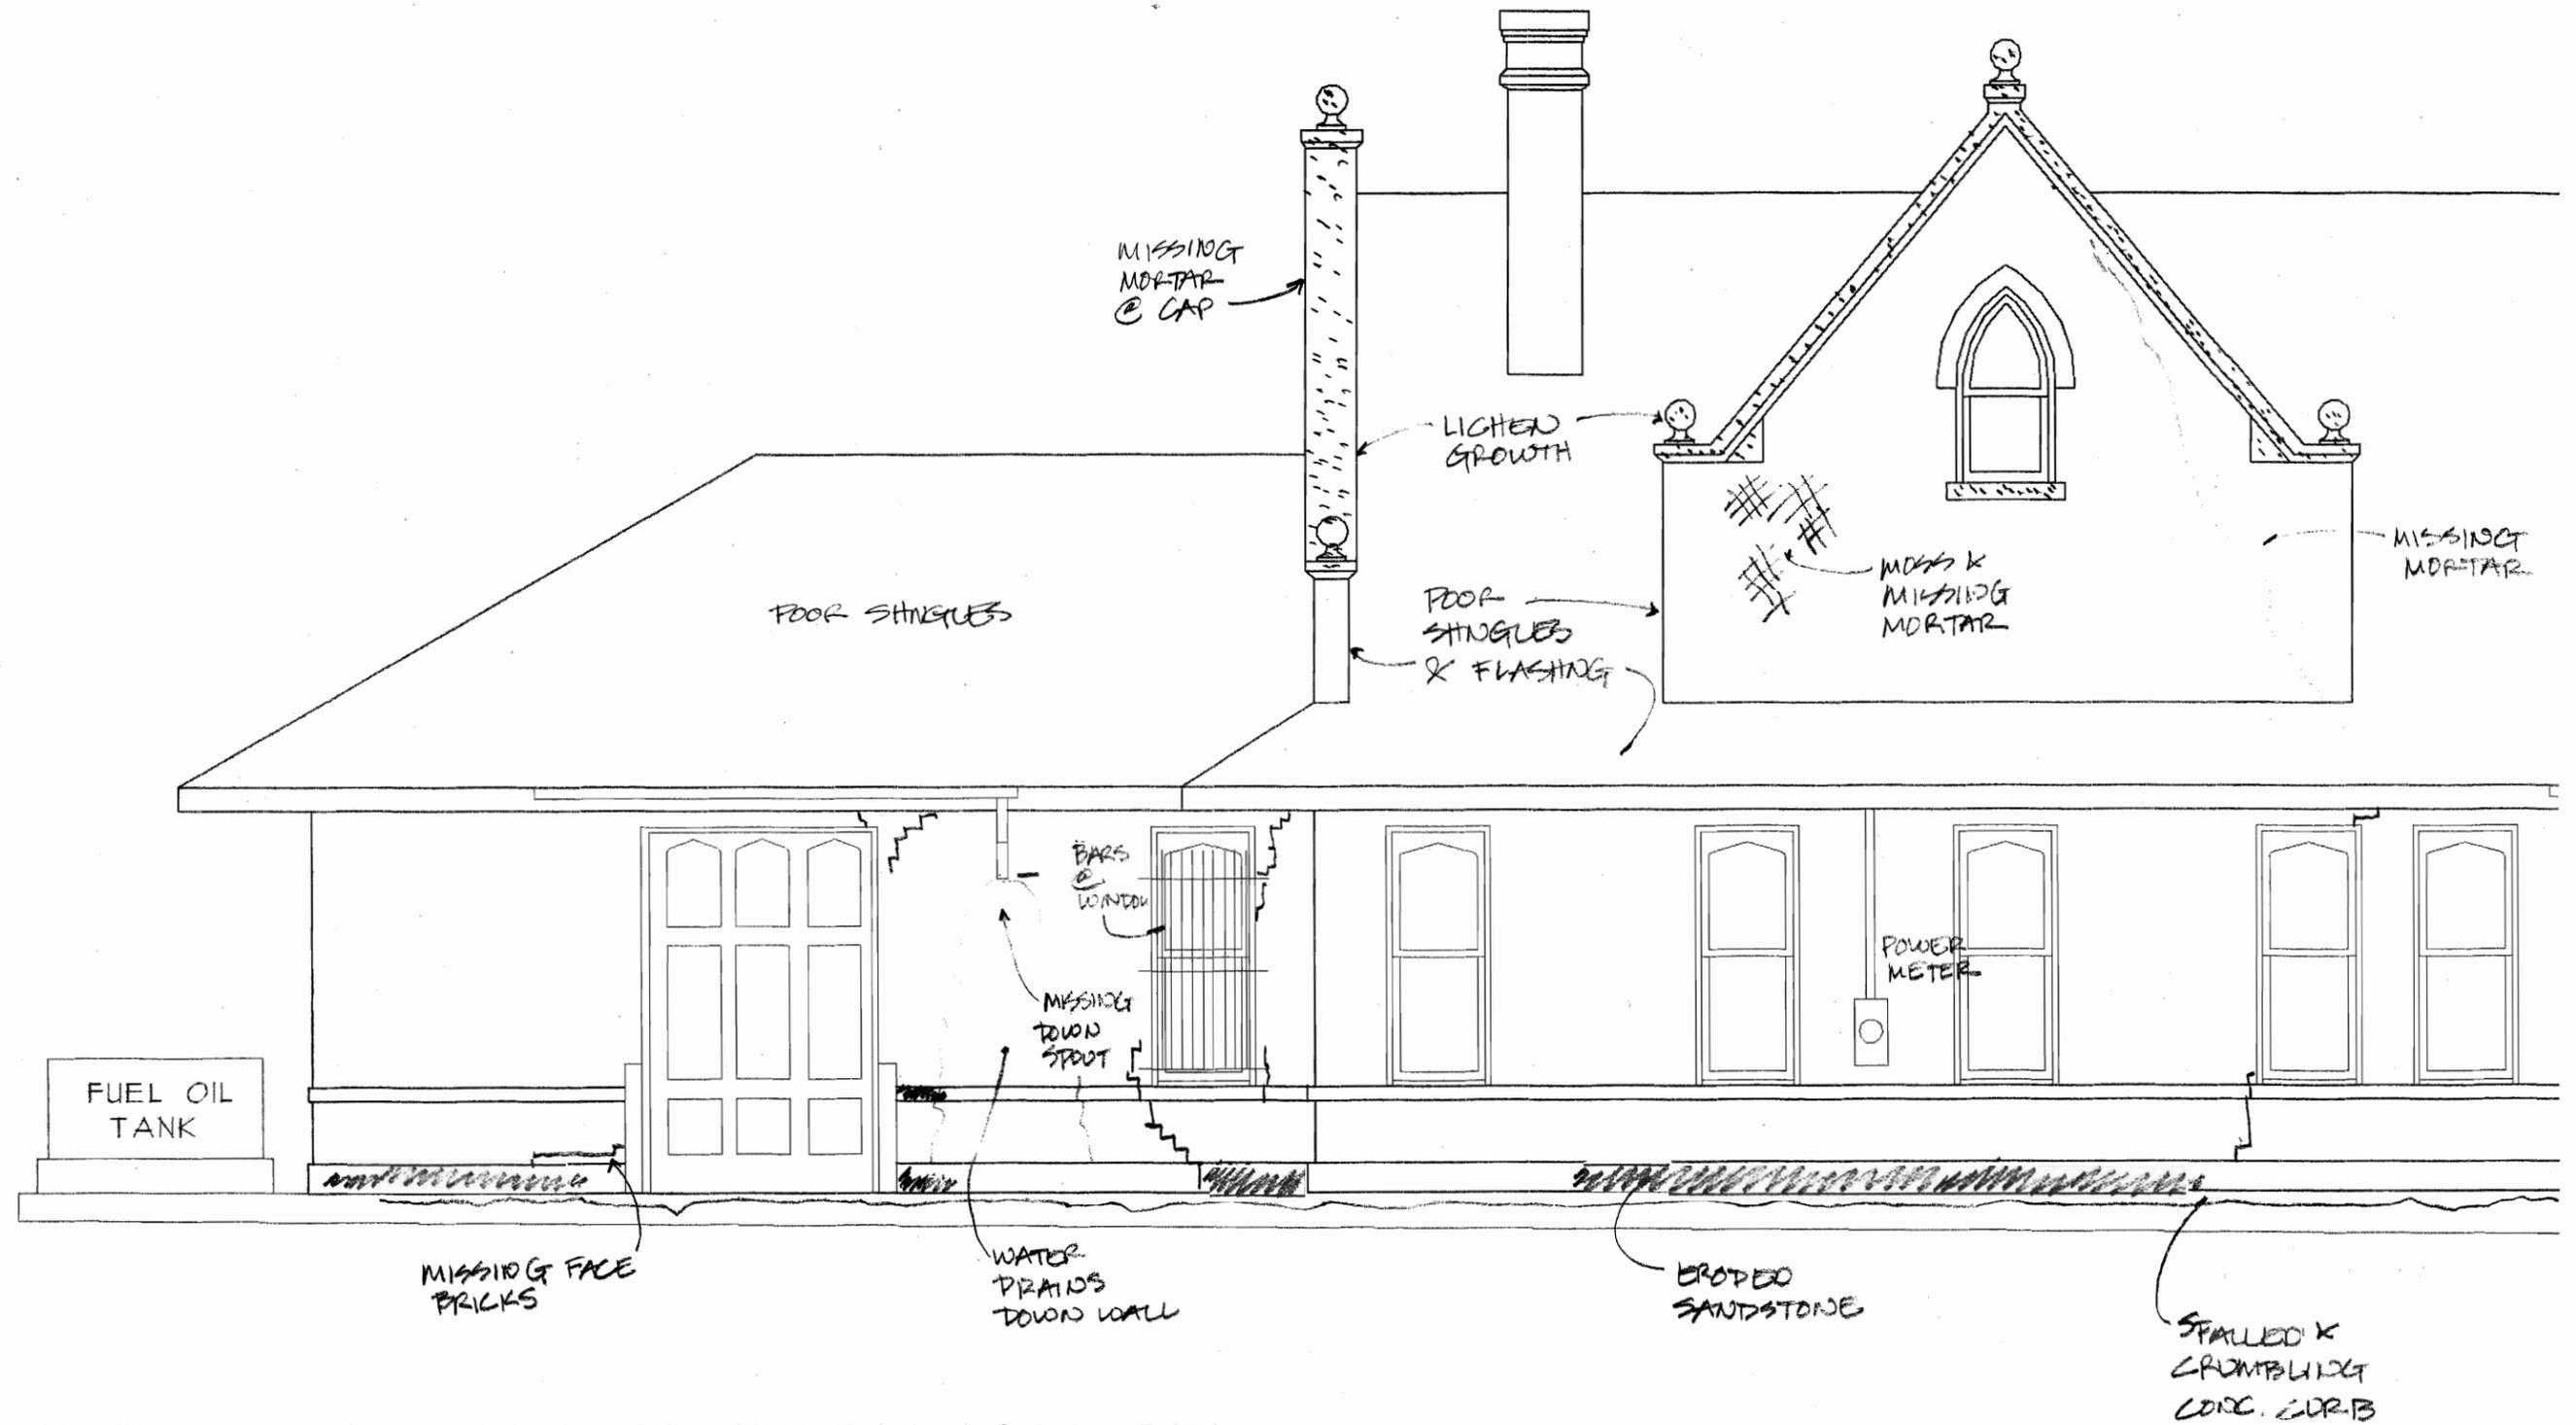
WEST ELEVATION (HIGHWAY 95)

SHOQUES & FLASHINGS
IN POOR CONDITION

SPALLED &
CRUMBLING
CONC. CURB

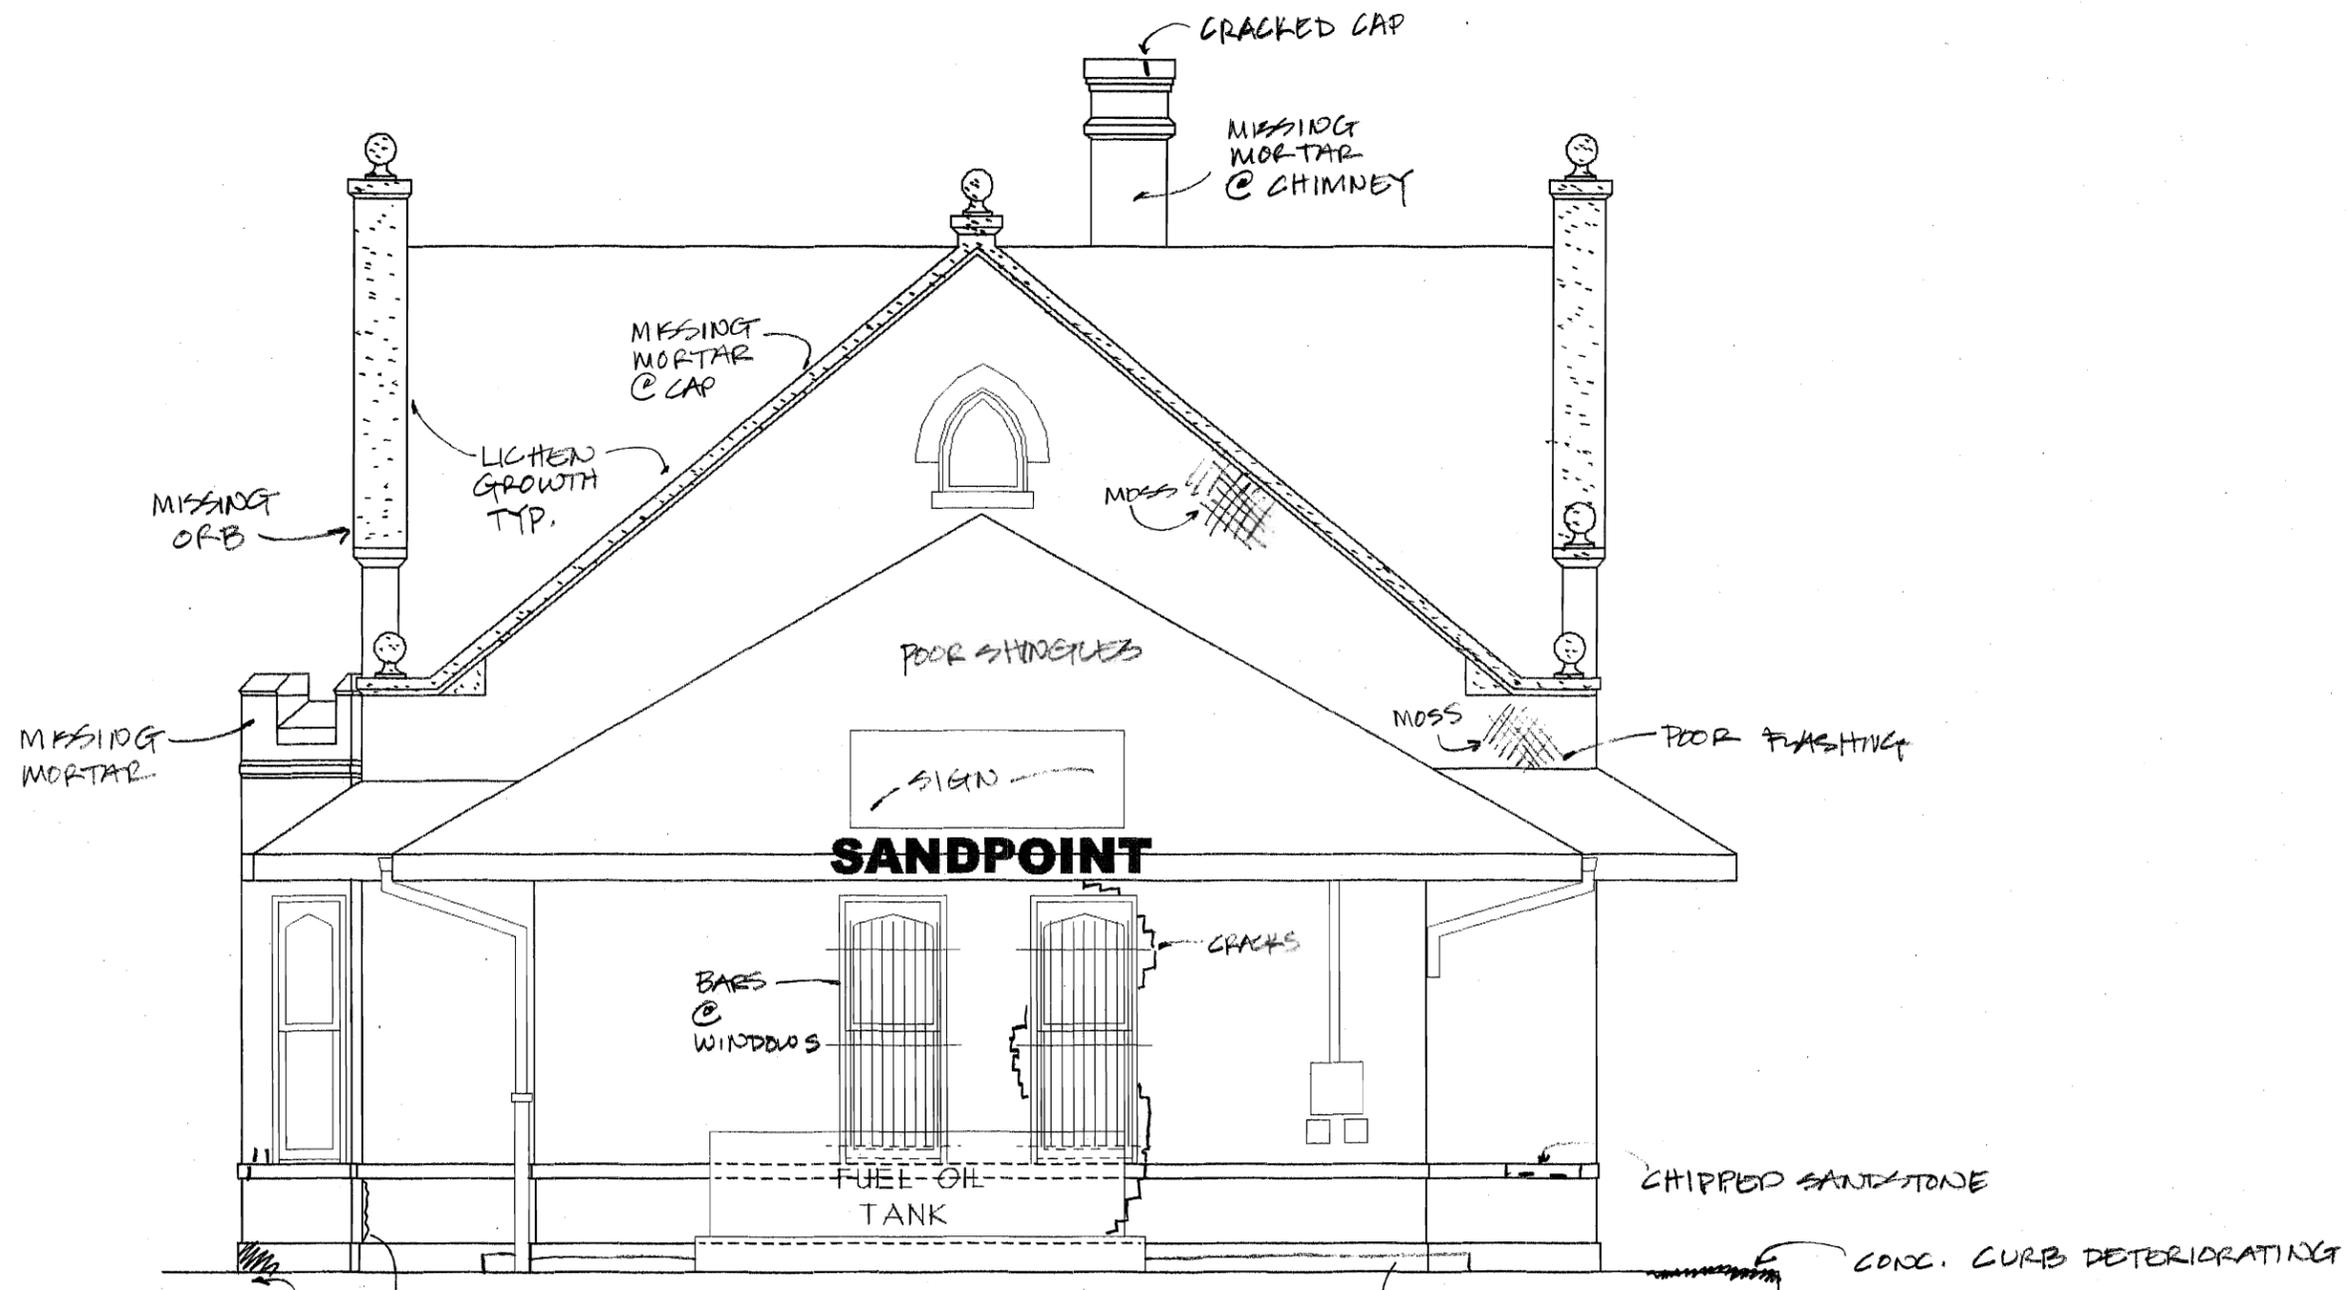
NORTH ELEVATION

- POOR CONDITION OF SINGLES
- NO TRIP EDGE @ ROOF FACIA IN POOR CONDITION ROTTING & PAINT PEELING
- BRICK REPLACEMENT DOES NOT MATCH

SETTLEMENT MONITORING
INSTALL $\frac{3}{8}$ " ϕ STAINLESS STEEL
BOLTS 3" INTO MORTAR JOINTS
APPROXIMATELY 6" FROM THE
CORNERS OF THE DEPOT.
INSTALL JUST BELOW SILL COURSE,
SO THAT HEAD PROJECTIONS BEYOND
SILL COURSE. 16 LOCATIONS
